# Manhole Inspection Summary

Manhole # S39W\_\_007MH

Insp Date: **2/26/08 3:02 PM**

**Location** Address: **rear 1739 covington st.**

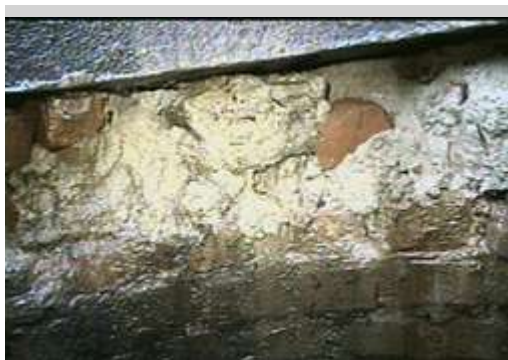
Defect 3

Condition: ☐ Sound ☐ Cracked ☐ Root Intrusion ☒ **Loose Brick** ☒ **Deteriorated**

Infiltration: ☐ None ☐ Joint ☐ Cracks ☐ Mortar ☐ Roots ☒ **Wall**

chimney loose bricks & deteriorated with infiltration from wall

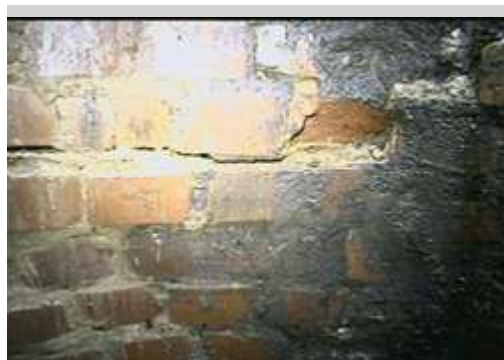
Defect 2

Condition: ☐ Sound ☒ **Cracked** ☐ Root Intrusion ☐ Loose Brick ☐ Deteriorated

Infiltration: ☐ None ☐ Joint ☐ Cracks ☐ Mortar ☐ Roots ☒ **Wall**

cracked corbel with infiltration at wall

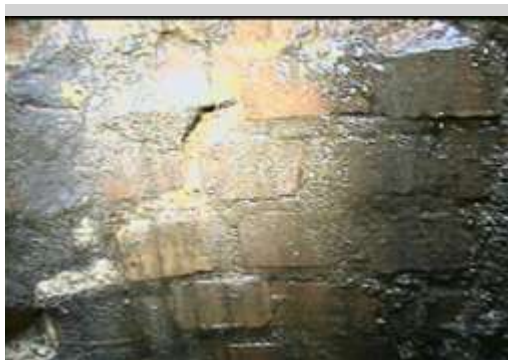
Defect 1

Infiltration: ☐ None ☒ **Joint** ☐ Cracks ☐ Mortar ☐ Roots ☐ Wall

barrel wall infiltration
